Report on the investigation of  
a sea cadet's fatal accident on board  
the sail training ship

***TS Royalist***

2 May 2010

**Report No 2/2011**  
**March 2011**

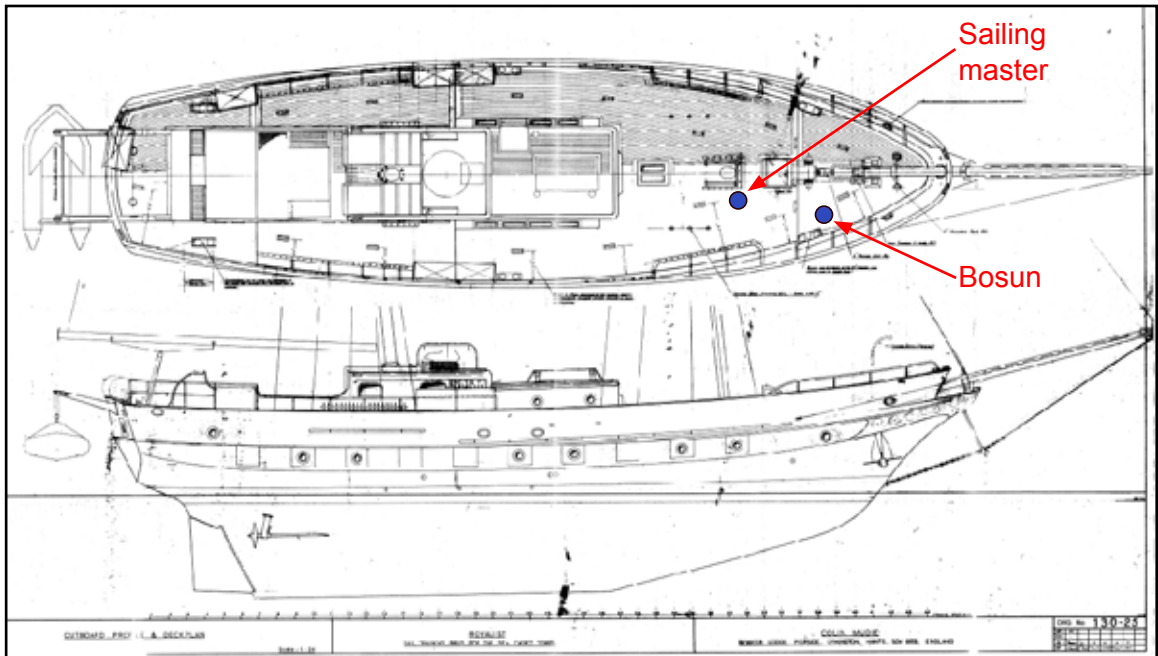
Figure 5

The main course was quickly furled and several cadets were sent from the main mast to assist the cadets working on the fore mast. The sailing master also went forward but remained aft of the bosun on the vessel's starboard side (**Figure 5**).

Approximate locations of sailing master and bosun

Although the sailing master and bosun were only about 8m below the cadets, it is highly likely that the effectiveness of their supervision was reduced by several factors. First, the view of some of the cadets aloft from the deck would have been partially obstructed by the fixed rigging. Second, it would have been extremely difficult to differentiate between the cadets and to monitor the actions of individuals because all the cadets were wearing red oil skins and were

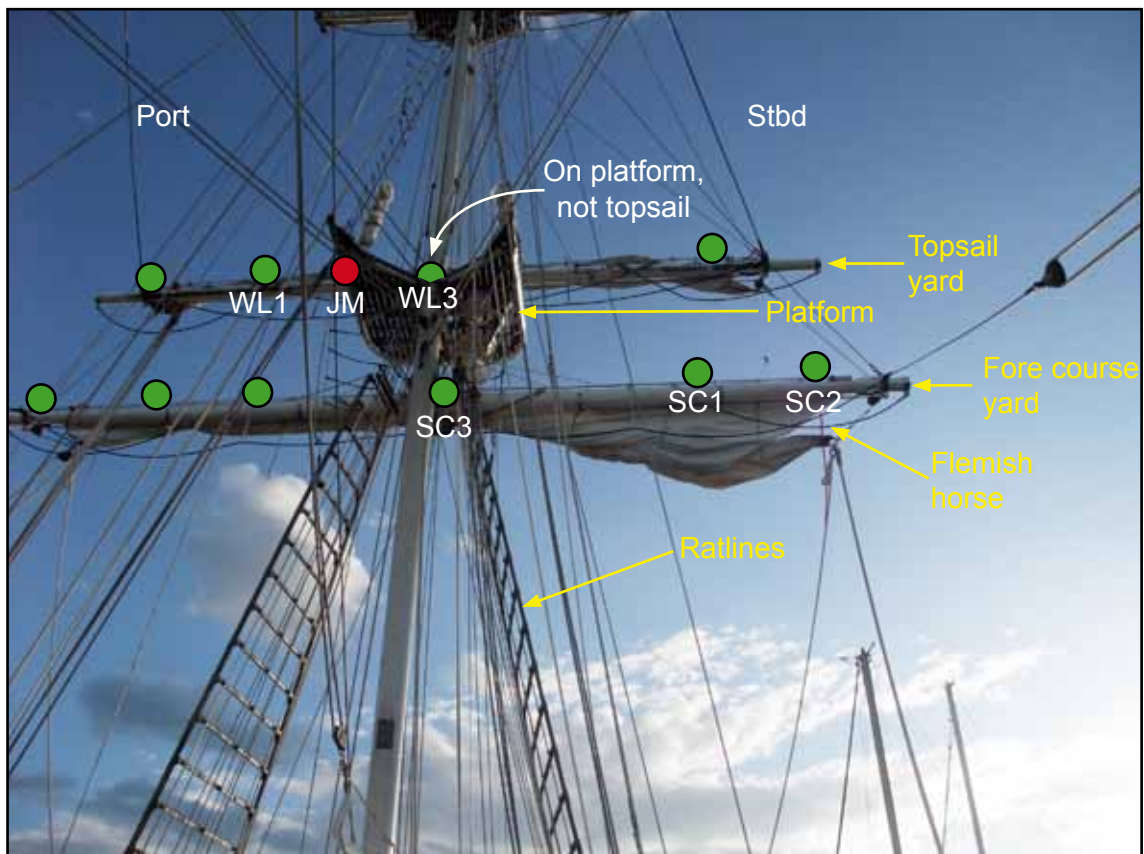
Figure 6

On the fore mast, four cadets were furling the fore topsail. One cadet was on the starboard yard and three cadets were on the port yard (**Figure 6**). Jonathan helped WL1 to stow the sail on the port yard while guiding a less experienced cadet on the port course yard below. WL1 was having difficulty in managing the task she had been set and, although not told to do so, Jonathan moved across to the starboard topsail yard to assist the lone cadet.

Six cadets were nominated to furl the fore course sail. Three cadets were on the port yard and two cadets (SC1 and SC2) were on the starboard yard; SC1 was about midway along the yard and SC2 was standing in the Flemish horse at the yard arm (**Figure 6**). SC2 was having difficulty in leaning over the yard to furl and secure the sail, and did not feel comfortable. The sixth cadet, the starboard forward watch leader (WL3), also felt uncomfortable aloft and remained on the platform or 'top' around the mast between the fore course and topsail yards.

Position of the cadets on the fore mast

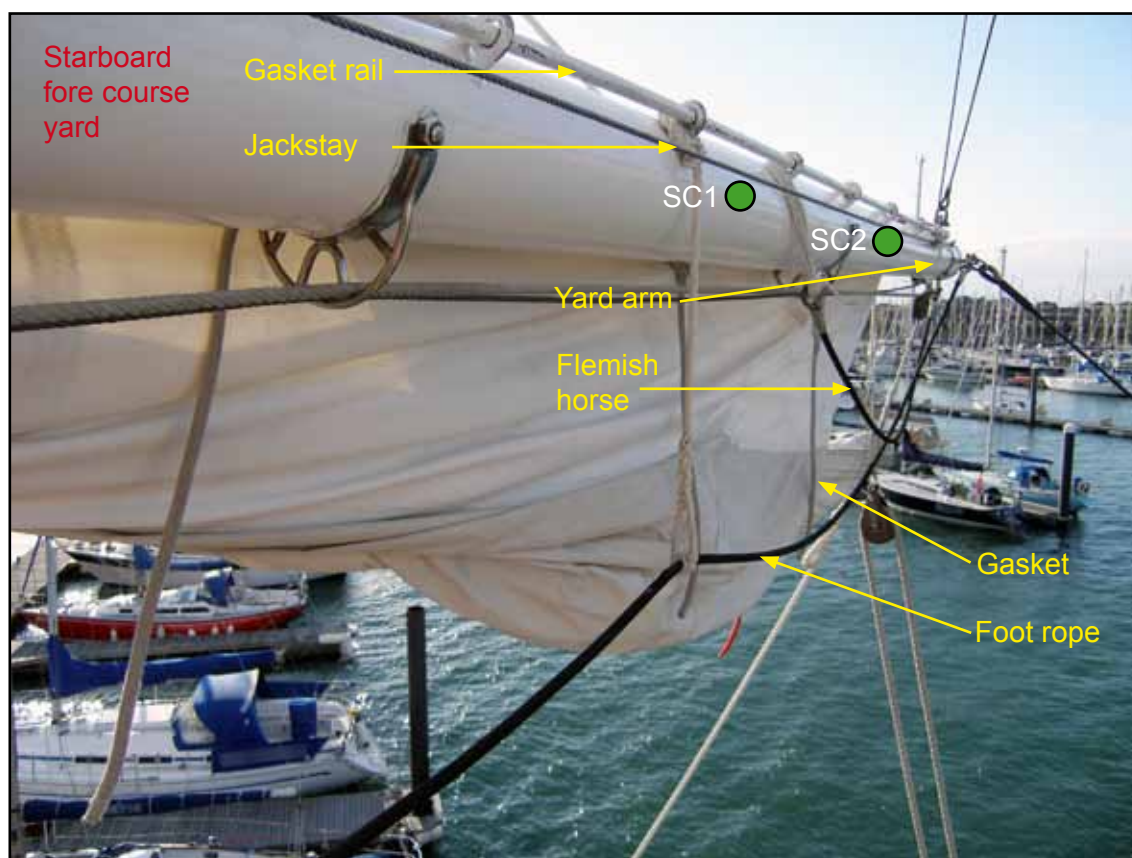
Figure 7

Jonathan climbed down from the platform via the futtock shrouds; it is not known if he clipped onto the vertical safety line available during this descent. He then stepped on the course yard foot rope between SC3, who was standing close to the mast, and SC1. Jonathan then clipped his belt harness lanyard on to the wire jackstay (**Figure 7**).

Starboard fore course yard

Jonathan started to help SC1 furl the sail. He then told her that he wanted to pass her so that he could assist SC2. SC1 told him not to; she would help the other cadet. Without further discussion, Jonathan unclipped his belt harness lanyard and tried to step around SC1, leading with his right arm and his right foot. SC1 immediately shouted to Jonathan to stop and to re-attach his belt harness. This instruction was heard by a cadet on the deck below. Jonathan managed to grab the metal gasket rail between the female cadets, but when his right foot stood on the foot rope between the girls, the foot rope swung forward causing Jonathan to lean backwards. Jonathan was unable to hold on and, although SC1 tried to grab his arm, she was unable to prevent him from falling towards the deck.

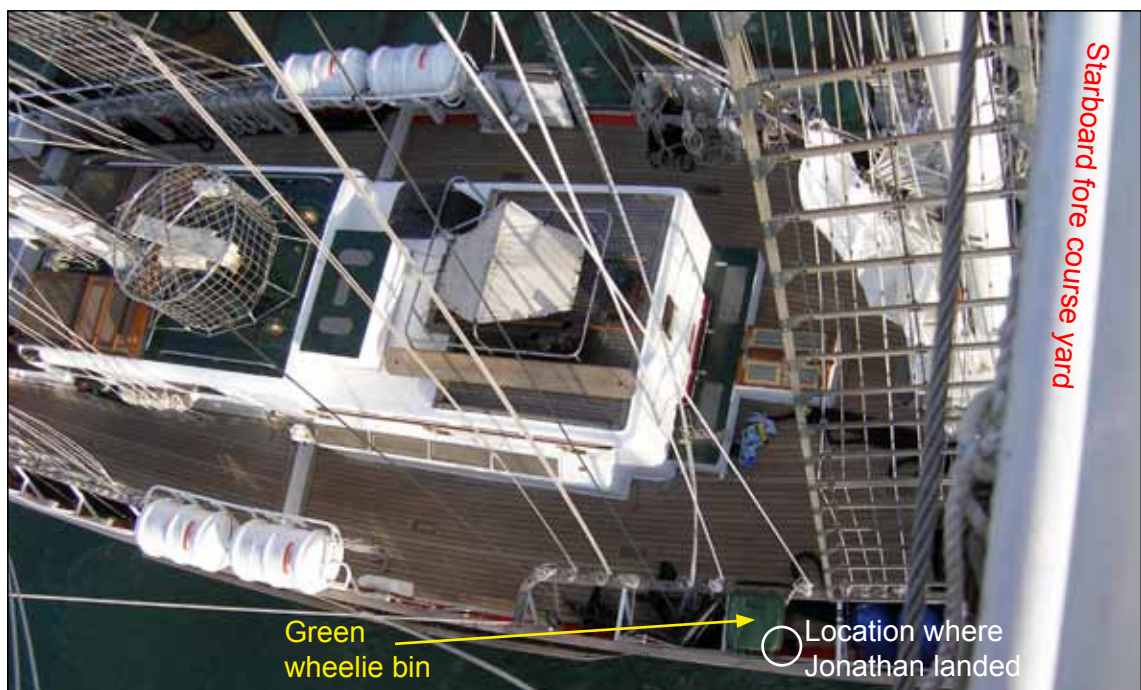
Figure 8

Jonathan landed face-down on the starboard gunwale and a green wheelie bin (**Figure 8**). He then fell in to the sea. Jonathan quickly surfaced face-up; his arms were outstretched and he showed no signs of movement. Although both the sailing master and the bosun caught sight of Jonathan as he fell, neither knew which yard he had fallen from.

View of deck from starboard fore course yard

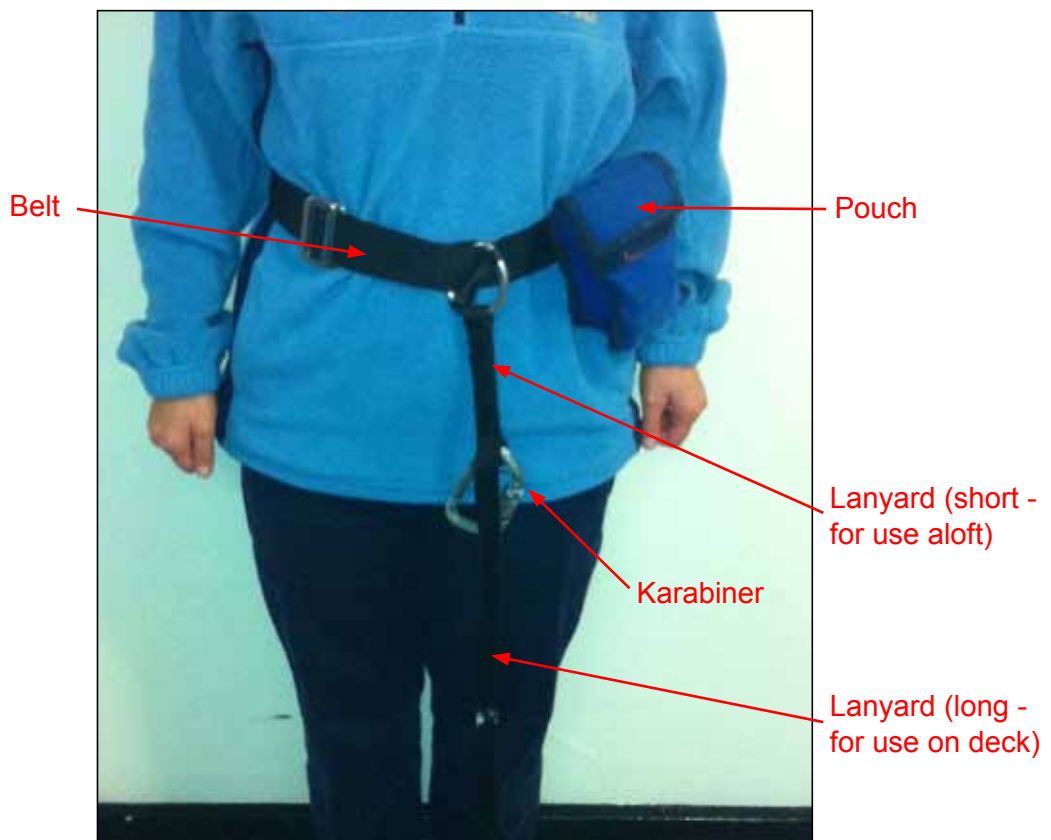
Figure 10

The harnesses used by the crew and cadets on board TS *Royalist* were interwoven polyester webbing belts fitted with a single lanyard (**Figure 10**).

Belt harness

The waist belt was 50mm wide and was fitted with a metal joining buckle. The lanyard was also made from polyester webbing and was 72cm long and 25mm wide, with a loop in the end. A self-closing karabiner<sup>7</sup> was fitted on the lanyard<sup>8</sup>, 13cm from the waist belt, which could be operated with one hand. It also locked automatically when closed. A pouch on the side of the harness was used to store the lanyard and karabiner when not in use.

The belt harnesses with a single lanyard used on board TS *Royalist* were intended to prevent the cadets from falling when aloft. However, this type of harness is a fall restraint device, which is intended to prevent the wearer from getting to a position from where it is possible to fall. It is not suitable as a fall arrest device because the belt only supports the wearer by the waist, although the risk of injury is mitigated to some extent by the lanyard's short length, which thus restricts the distance a person can drop. However, the potential for injury remains. Furthermore, given the material breaking load of the lanyards and the absence of markings on the harnesses to indicate that they met the relevant EC standards (paragraph 1.7.1), their ability to withstand the shock loading of a person falling is questionable.

The provision of only one lanyard also necessitates the wearer to 'unclip' while moving around when aloft due to the arrangement of vertical safety lines and horizontal wire jackstays. During the periods a cadet is 'unclipped', the risk of falling is significantly increased.

However, the STI guidelines also state that account must be taken of the specific rig of a vessel. In this case, it is evident that MSSC preferred the waist belt with one lanyard to the recommended full body harness with two lanyards, which it had trialled and which is used by other operators, on the basis that it was simpler to use, less cumbersome, and suitable for use on deck as well as aloft provided the cadets were properly trained in their use. These were important considerations given the age range and mixed abilities of the embarked cadets and the limited space on the masts and associated rigging on board TS *Royalist*. Nonetheless, not only were the belt harnesses and lanyards unsuitable for fall arrest, they were neither manufactured nor tested to comply with current standards. In addition, despite the frequent on board inspections conducted, no records of these inspections were maintained. Consequently, despite their good safety record, the belt harnesses cannot be considered to have been fit for purpose.

Jonathan's belt harness and lanyard did not fail, and there was no record of a belt harness failing on board. However, despite MSSC's reviews of the harnesses, the continued use of the belt harnesses with single lanyards, and the maintenance regime followed, indicate that MSSC had not adopted best practice found elsewhere in the sail training sector of the marine industry. They also indicate that MSSC had not complied with the spirit of the regulatory standards for PPE applicable to the merchant marine industry and to adventurous training activities ashore.

STI guidelines advise that sail training vessels use a full body harness fitted with two lanyards. This is a fall arrest device, intended to be used in situations when a fall is likely, and designed to minimise the risk of injury to the wearer, suspend them in an upright position and maximise the chance of their safe recovery or rescue, if required. The provision of two lanyards also enables the wearer to 'clip' on to the next line or wire before 'unclipping' from the line or wire in use. Although two lanyards present twice the snagging hazard of a single lanyard (and a degree of synchronisation, discipline and practice is required), the increased protection from falling is clear.

Following discussions with the RN, MSSC withdrew TS *Royalist* from service in September 2010 for refit, and pending a review of the equipment and procedures used by cadets when aloft. It has also continued to investigate the provision of a suitable replacement harness and is progressing the development of an SMS for its offshore operations.
